ERGONOMIC INTERVENTIONS AT UNIMIN

W. Porter, NIOSH, Pittsburgh, PA
A. Mayton, NIOSH, Pittsburgh, PA
A. O'Brien, Unimin Corp., Winchester, VA

Abstract

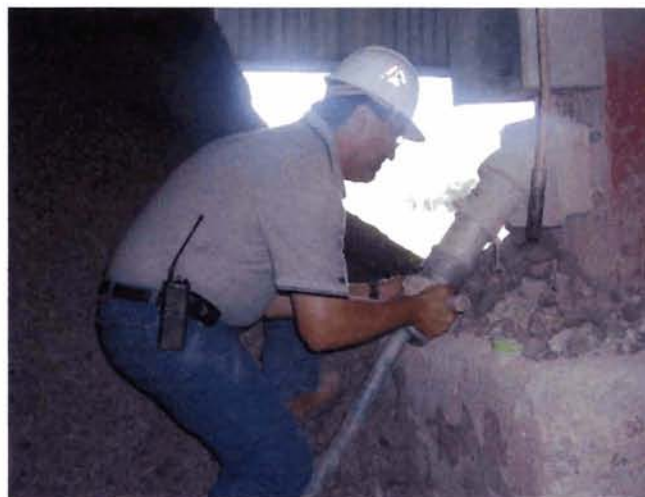
Figure 1. Mine worker demonstrates power connection.

power cable (Figure 1). Issues of concern included the following:

- 1) The aluminum sleeve became bent, which made it difficult to connect and disconnect from the receptacle.
- 2) Hardened and built up clay on the connectors made it difficult to insert into the receptacle.
- 3) Dust on the aluminum sleeve made it more difficult to connect.
- 4) Awkward postures (rounded back, arm position with respect to the body, and standing on uneven ground) occurred when connecting and disconnecting the cable to the power source.

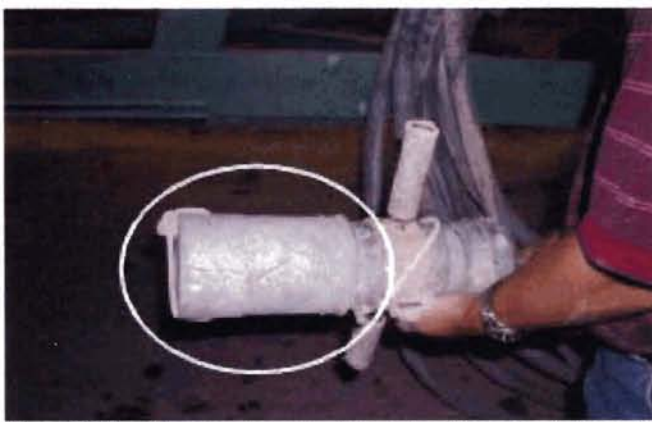
Figure 2. The rubber “boot” to protect the male cable connector from dirt, dust, and damage.

- 1) A rubber boot (Figure 2) for the aluminum sleeve was installed on the male end to prevent the sleeve from bending and to keep it clean. The rubber boot was made from a protective cover for a dust collector cartridge that the mine normally stocks.
- 2) An electric grinder was used to file burrs on the inside of the connectors to make insertion of the plug easier.
- 3) A spray lubricant, commonly known as “Super Slick,” was applied to the contacts and sleeve of the connector to reduce friction when inserting the connector into the receptacle.

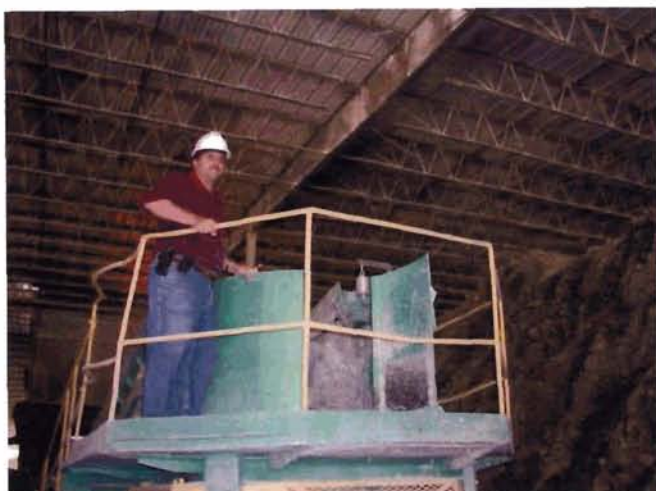
Figure 4a. Shredder tub with door installed.

A team consisting of mine management, maintenance personnel, and shredder operators conducted intensive brainstorming sessions to reach a low-cost effective solution. It resulted in cutting the tub to create a hinged door (Figures 4a and 4b). This intervention demonstrated the following benefits:

- 1) Reduced the risk factors associated with leaning over the side and climbing over the side of the tub. The worker was now able to walk into the tub to perform cleaning or maintenance duties.
- 2) Reduced the injury risk associated with lifting heavy rocks to shoulder height and above to throw them over the top of the tub side. Instead workers are able to use the door of the tub to easily slide out rocks and debris.
- 3) Allowed operators to safely carry maintenance tools into and out of the tub.

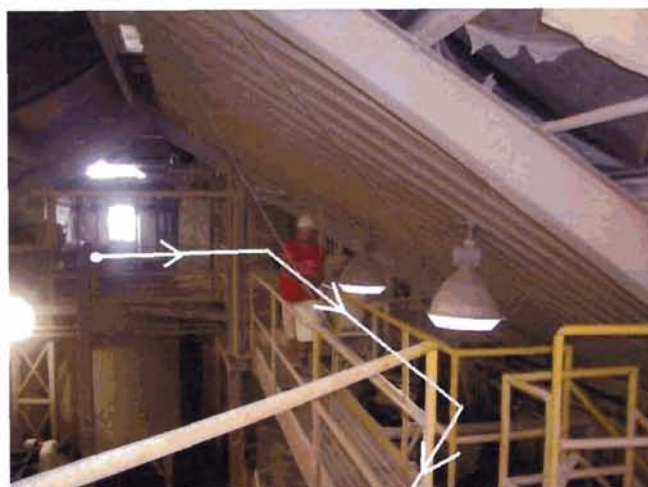
Figure 5a. Pre intervention transportation of the bucket (arrow depicts walking path).

Another task which was improved as a result of the NIOSH-Unimin collaboration was the handling of a clay additive, sodium silicate. The sodium silicate is added in 50 pound increments to the ball clay slurry up to three times a day. Originally the additive was dispensed into a bucket and then carried along a catwalk for about 50 feet (Figure 5a). This catwalk was very narrow and forced workers to carry the bucket one handed in front of or behind their body or to walk sideways.

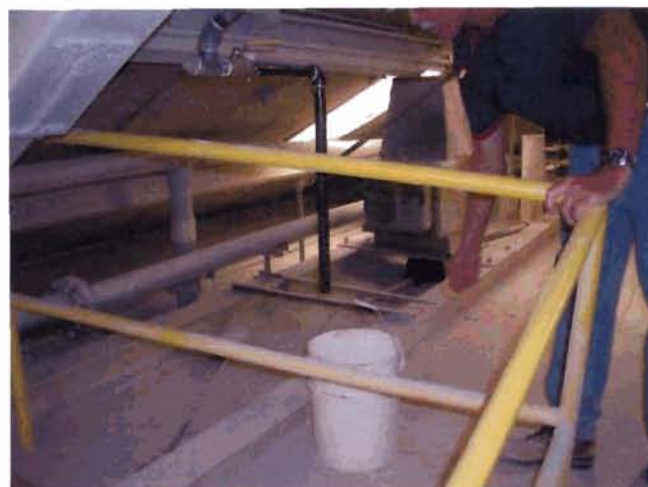
Figure 5b. Post intervention filling of the bucket (occurs at end of path way shown in Figure 5a).

NIOSH researchers recommended extending the piping for the additive over to its destination to eliminate carrying the load. As shown in Figure 5b, it would still be necessary to pour the additive into the slurry by bucket, but workers would no longer carry it 50 feet. The cost of implementing the intervention was approximately \$300. The installation was straightforward since the additive was already piped. They simply added a pump and lengthened the pipe. The employees liked the idea and quickly put it in place.
